NRL/MR/6180--97-7919

Results of Damage Control Tactics and Equipment Tests—Phase III: Cold Water Tests

13. ABSTRACT (Maximum 200 words) This report summarizes data from the cold water series of damage control tests involving pipe patching and hull repair. Two different anti-explosure suits were also evaluated.

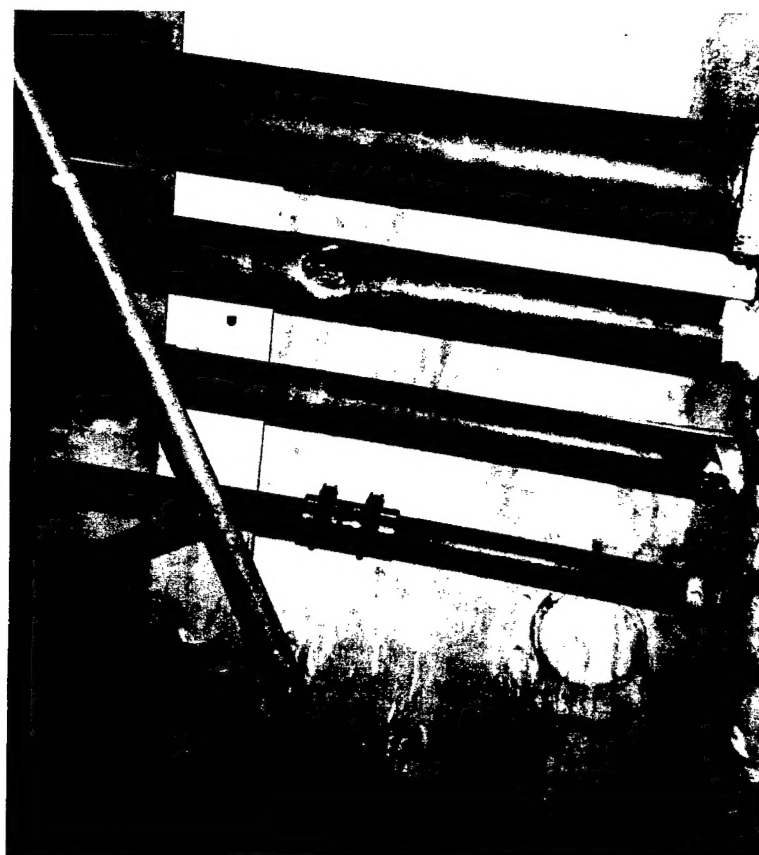
Fig. 3 - Pipe mockup in Upper Wet Compartment

The firemain consisted of a loop between FR 91 and FR 95. A line branched off of this loop on the inboard side of the compartment at FR 91. This line extended to FR 88, where it turned and extended to the outboard bulkhead. This line supplied the pipe mockup located along the outboard bulkhead at FR 88. All of the pipe in the firemain loop was copper-nickel (90/10) with an outside diameter of 88.9 mm (3.5 in.) and a wall thickness of 2.4 mm (0.095 in.). The pipe mockup, shown in Fig. 3, contained several different pipe sizes. The pipe used during these tests had an outside diameter of 114 mm (4.5 in.) and had a wall thickness of approximately 3 mm (0.125 in.).

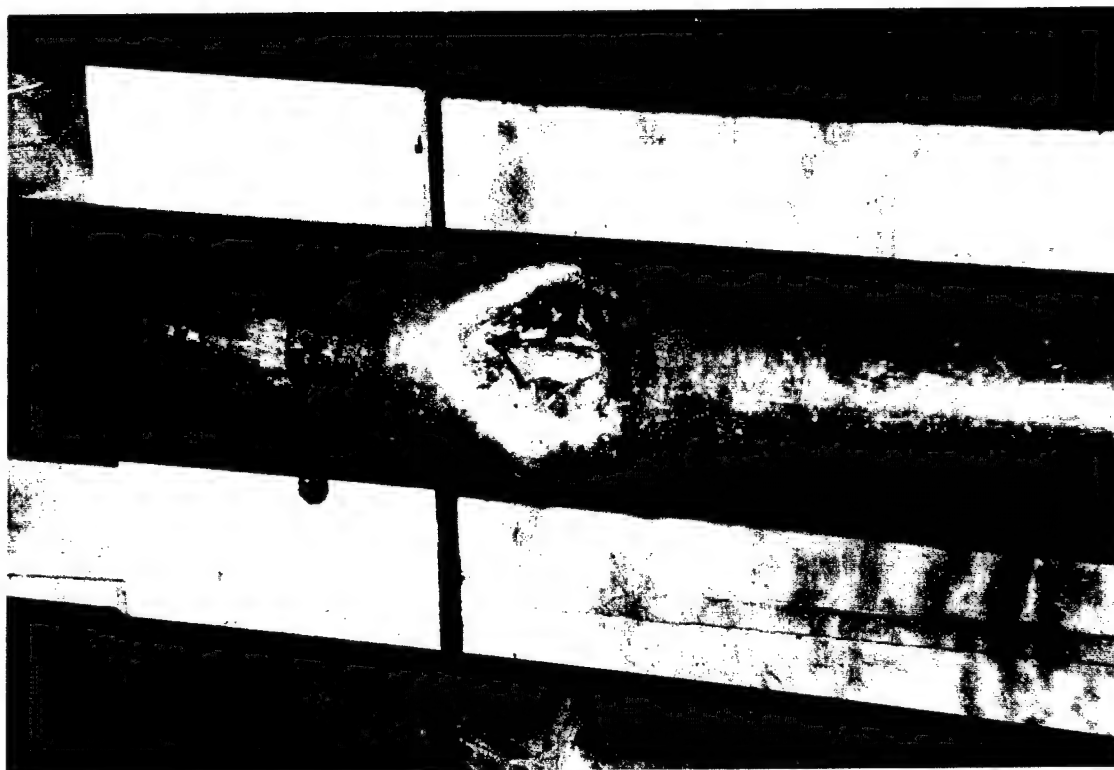
Fig. 6 - Pipe mockup rupture in 114mm (4.5 in.) diameter pipe

The pipe mockup rupture, shown in Fig. 6, simulated compound damage with jagged edges. This rupture, measuring 50.8 mm (2.0 in.) by 50.8 mm (2.0 in.), flowed approximately 946 ℓ pm (250 gpm) and had a residual pressure of 2.2 bar (32 psi). The second firemain rupture, shown in insert Fig. 5 -Chill water pipe rupture

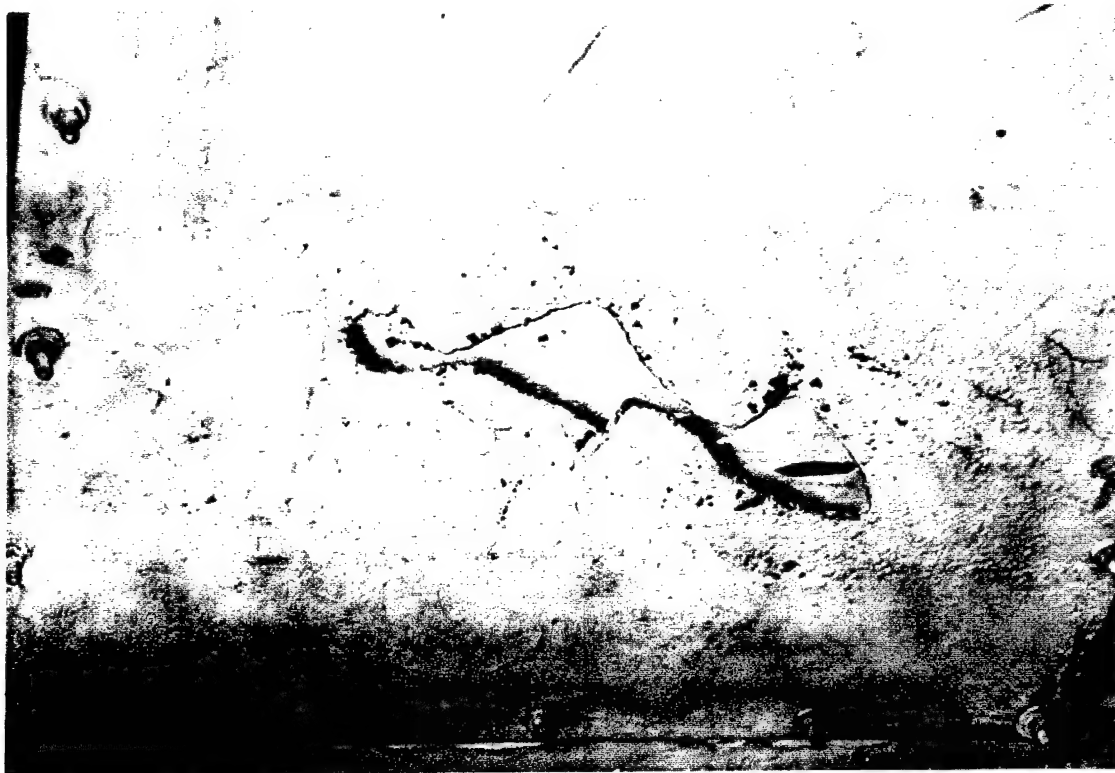
Fig. 9 - Rip/gash hull rupture

Two types of hull ruptures were used during this test series. Both of the hull ruptures were supplied by water contained in the double hull (storage) and pilot house tanks. The hull ruptures were located in the storage tank (Fig. 2). Water contained in the pilot house, located above the storage tank, supplied the storage tank with additional water. The first rupture, shown in Fig. 8, was intended to simulate an explosion rupture. This rupture consisted of a single circular hole with a diameter of approximately 178 mm (7 in.). Initially, the rupture flowed 13497 ℓ pm (2969 gpm) with a static head of 5.3 m (17.5 ft). After three minutes of unobstructed flow (i.e., no repair in progress) the rupture flowed 6233 ℓ pm (1371 gpm) with a static head of 1.1 m (3.7 ft). After 4 minutes of unobstructed flow the water in the tank was at equilibrium with the water in the Upper Wet Compartment. The second rupture, shown in Fig. 9, simulated a rip or gash in the hull. This rupture had a total hole area of approximately 161 cm² (25 in²). Initially, the rupture flowed 10,064 ℓ pm (2659 gpm) with a static head of 5.5 m (18 ft). After three minutes of unobstructed flow, the rupture flowed 8709 ℓ pm (2301 gpm) with a static head of 4.1 m (13.5 ft). After 4 minutes of unobstructed flow the water in the tank was at equilibrium with the water in the Upper Wet Compartment.

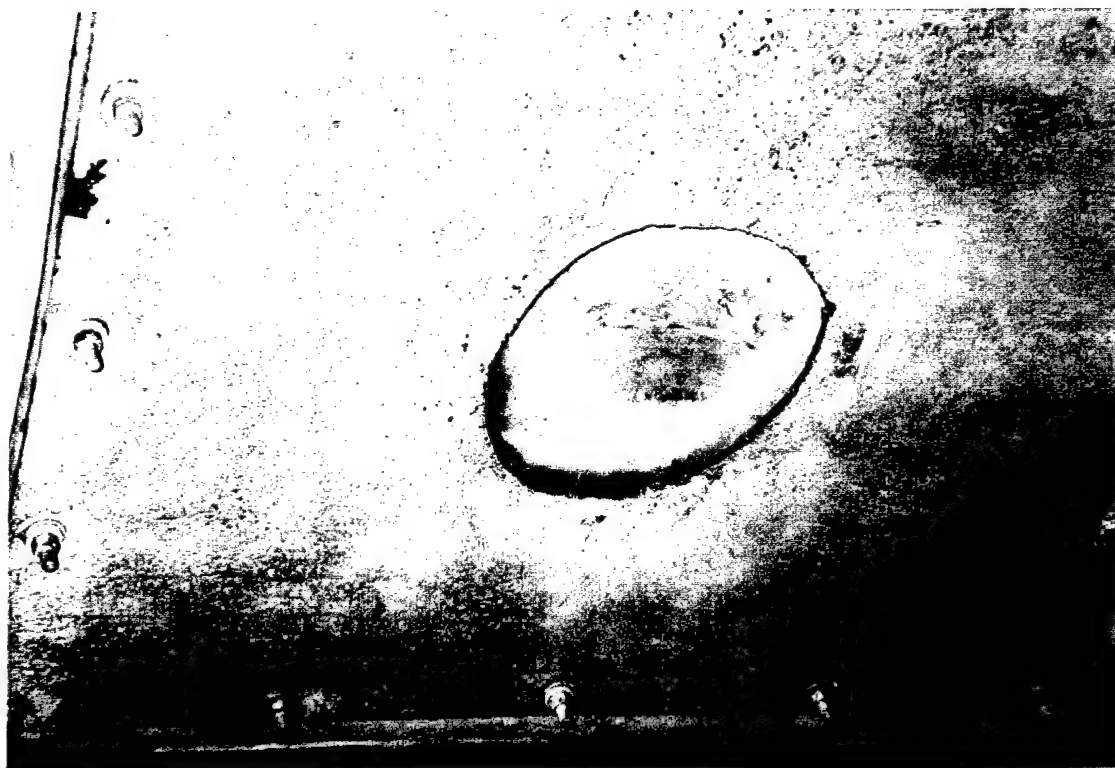
Fig. 8 - Explosion hull rupture
